# **INDOOR AIR QUALITY REASSESSMENT**

**Clarksburg Elementary School  
Clarksburg School District  
777 West Crossroad  
Clarksburg, Massachusetts**

Prepared by:  
Massachusetts Department of Public Health  
Bureau of Environmental Health Assessment  
February, 2001

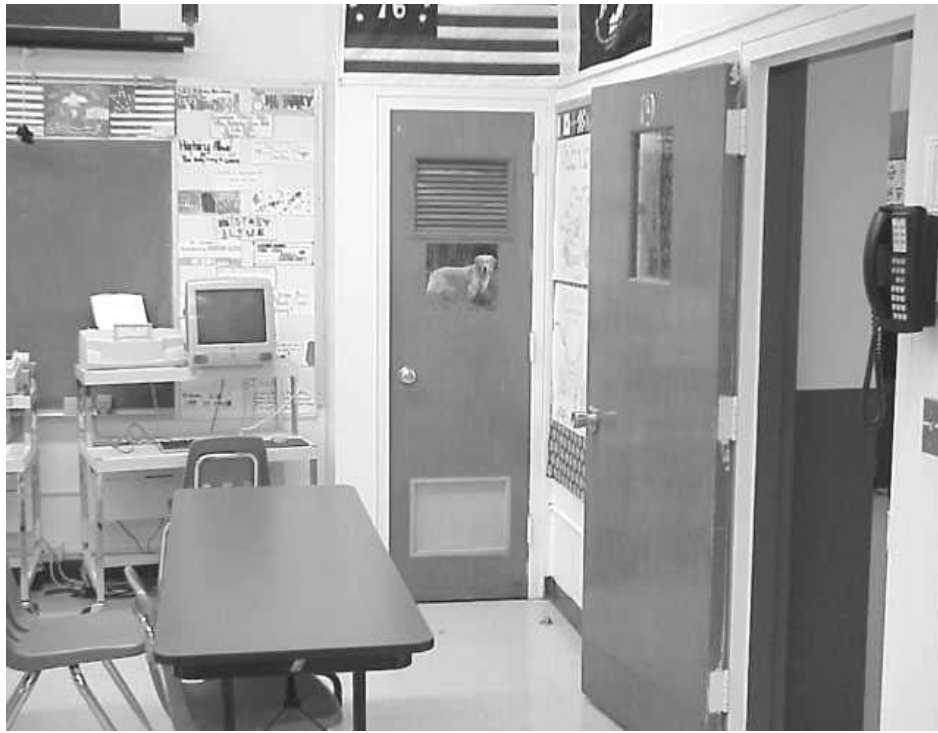
**Picture 1**

Efforts have been made to eliminate blockages from ventilation vents. However, some classrooms still have blocked univents. The passive door vents in the closet doors were moved to the top of the doors as recommended (see Picture 1).

**Passive Door Vents in the Closet Doors Were Moved To the Top of The Doors As Recommended**

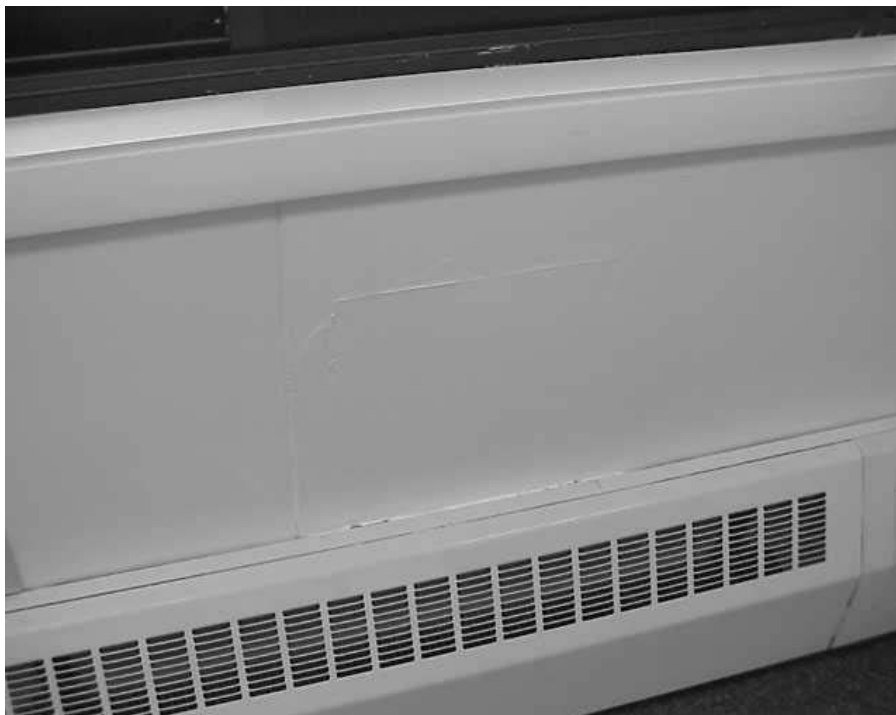
**Picture 2**

The vent grille was removed and the wall hole was sealed (see Picture 2).

**Sealed Vent in Room 5**

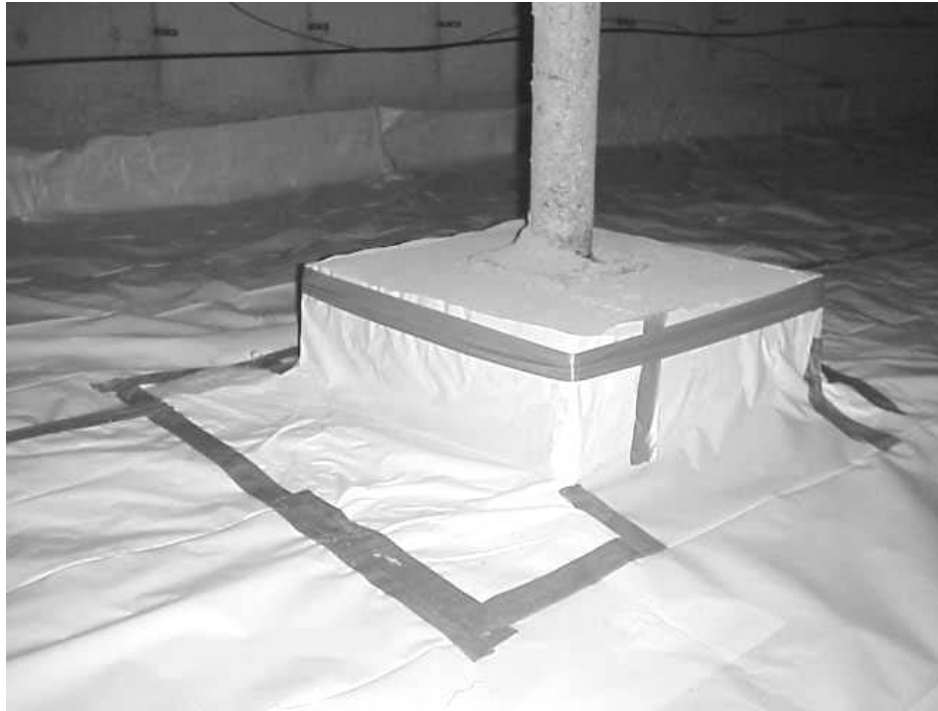
**Picture 3**

Debris was removed from the crawlspace floor (see Picture 3). The floor has been sealed with a plastic vapor barrier to prevent water penetration`.

A vapor barrier was installed on the floor of the crawlspace (see Picture 3)

**Debris Removed from Floor of Crawlspace, Plastic Vapor Barrier Installed over Floor**

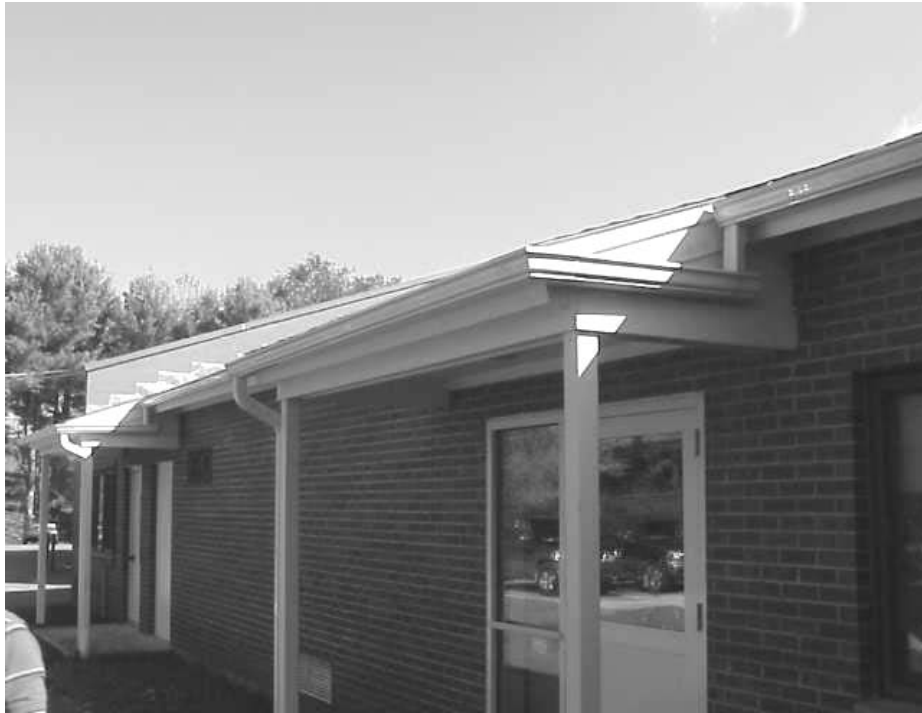
**Picture 4**

A gutter downspout system was installed along the roof edge (See Pictures 4 and 5). Downspouts are connected to a storm drain that directs water away from the base of the building. The interiors of foundation walls were dry and appeared to be free of moisture (see Picture 6).

**New Gutter Downspout System was Installed Along the Roof Edge**

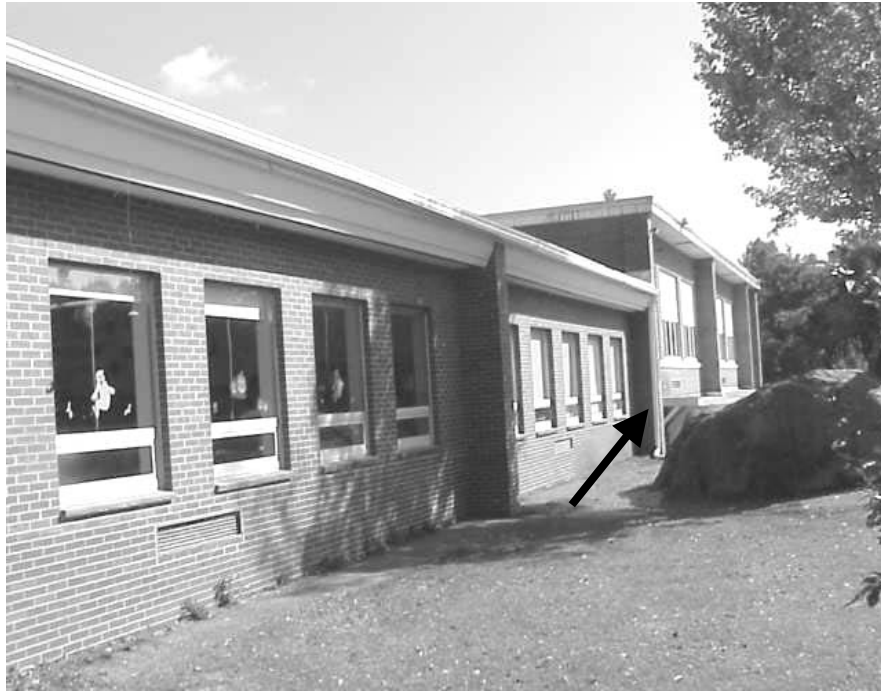
**Picture 5**

**New Gutter Downspout System was Installed along the Roof Edge**

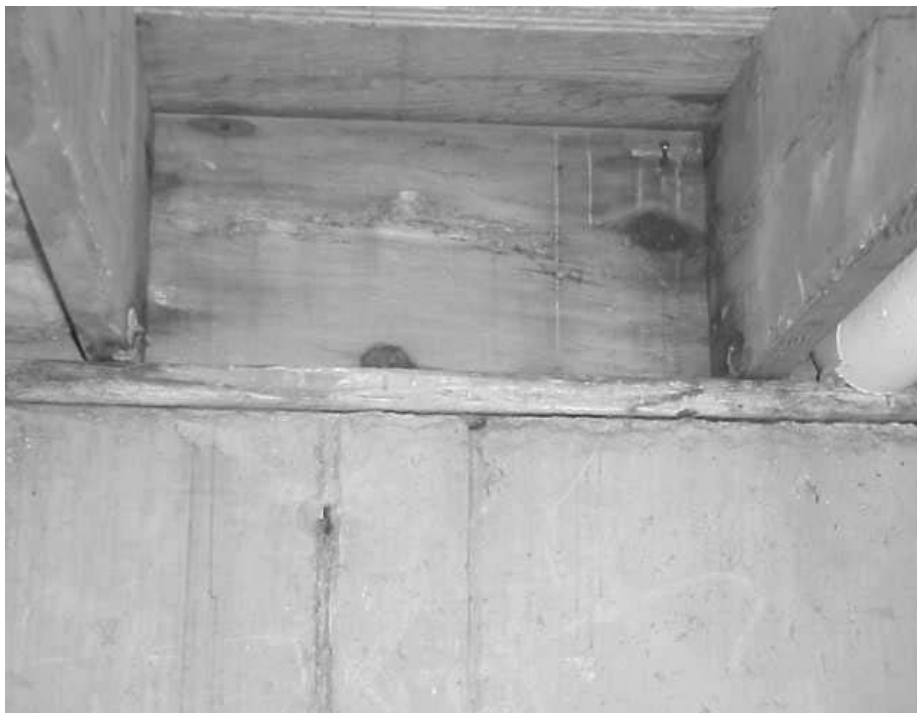
**Picture 6**

**Foundation Wall Dry After Gutter/Downspout Installation**

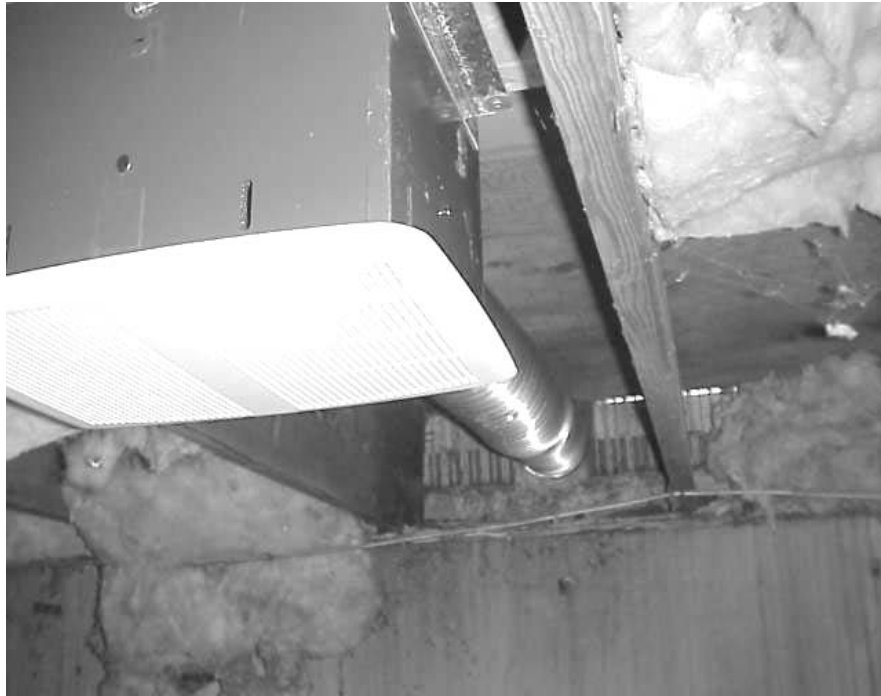
**Picture 7**

A mechanical exhaust vent system was installed in the crawlspace (see Picture 7). This exhaust vent draws crawlspace air and expels it directly outdoors (see Picture 8).

**Mechanical Exhaust Vent System Installed in the Crawlspace**

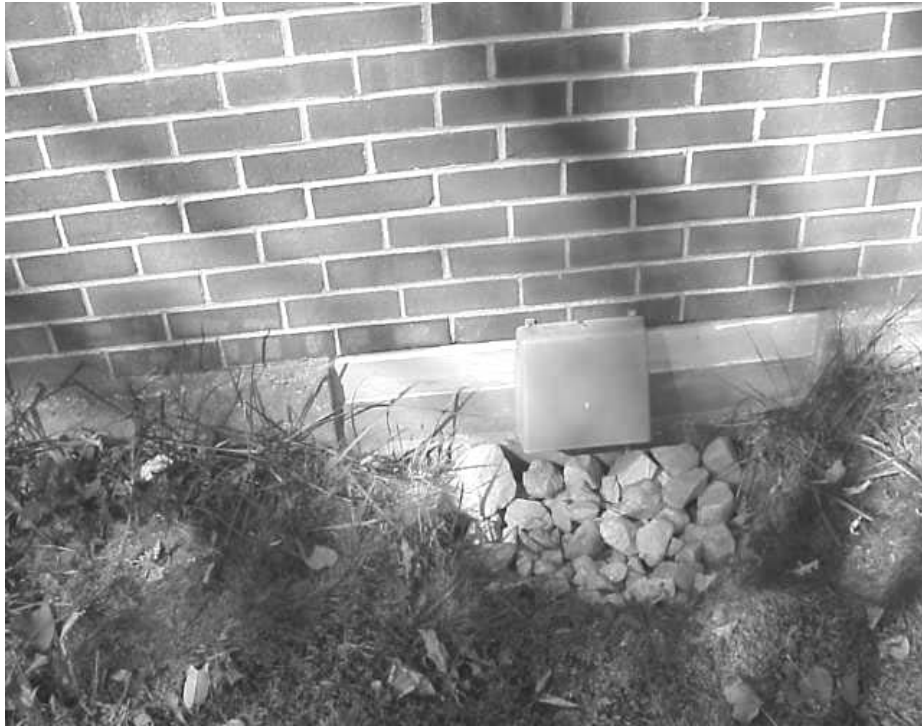
**Picture 8**

**Crawlspace Exhaust Vent Terminus**

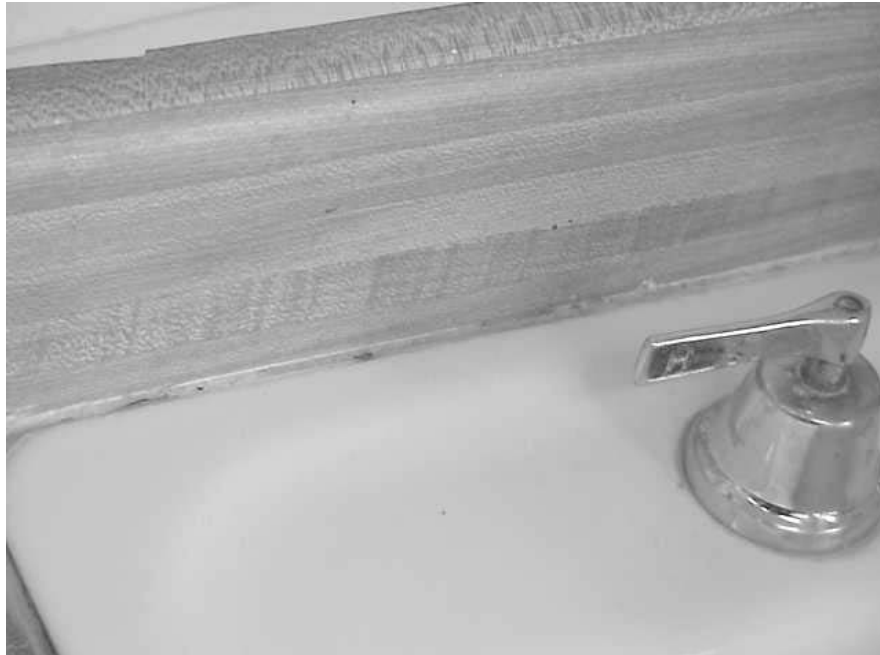
**Picture 9**

Several classrooms have sinks that have a seam between the countertop and wall. Water penetration through this seam can result if not watertight. Water can penetrate the countertop seam and collect behind this board. Water penetration and chronic moisture exposure to plywood, corkboard and other porous materials can cause water damage and serve as a growth medium for mold. As a preventative measure by maintenance staff, these seams were sealed throughout the school with a caulking material (see Picture 9).

**Sink Back Splash/Counter Seam Sealed With Caulking**

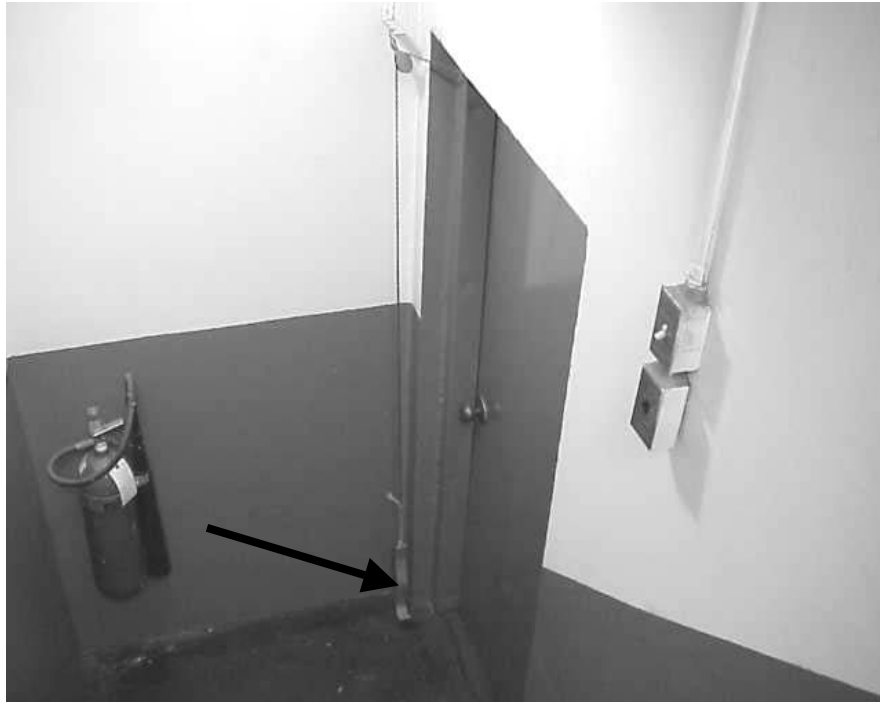
**Picture 10**

An odor was noted emanating from the stairs leading to the boiler room. These odors were attributed the boiler room door being ajar (see Picture 10). A counterweight that would close this door flush with the doorframe was missing. Boiler room odors can be irritating to the eyes, nose and throat.

**Boiler Room Door Missing Counterweight**

3. Replace missing counterweight to boiler room door.
4. Move plants away from univents in classrooms. Examine drip pans for mold growth and disinfect with an appropriate antimicrobial where necessary. Consider reducing the number of plants in certain areas.
